Palisades Subbasin

2019 Total Maximum Daily Load and Five-Year Review

Hydrologic Unit Code 17040104

State of Idaho
Department of Environmental Quality
May 2019

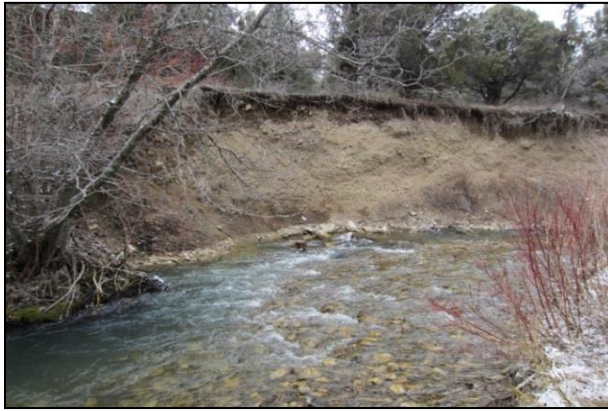
Figure 5. Before restoration activities.
Source: USFS.

Before and after restoration conditions are shown in Figure 5 and Figure 6.

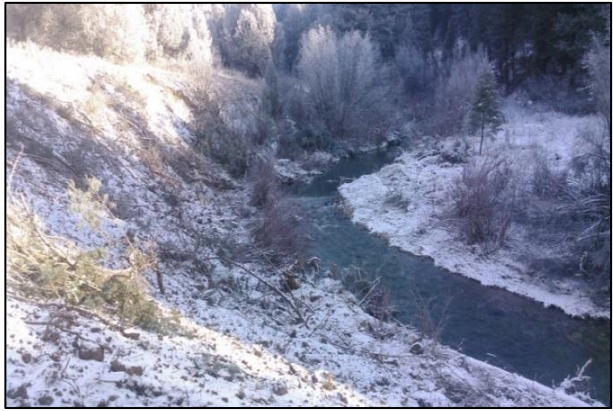
Figure 6. After restoration activities.
Source: USFS.

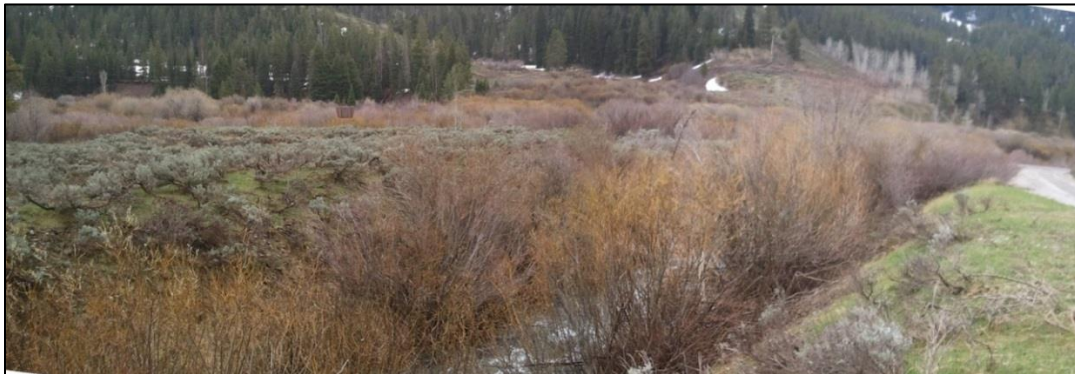
Figure 8. Looking down the valley along Forest Service Road 230 (on the right) at the downcut 3 to 5-foot West Pine Creek. The channel is disconnected from the floodplain and contains limited riparian and wetland habitat (before). Source: USFS.

The associated stream restoration work on West Pine Creek meandered the straightened, ditch-like channel, increasing the length from approximately 907 feet to 1,143 feet and restoring an additional 236 feet of channel and associated aquatic habitat. The increase in channel length decreased stream slope and stream flow, which created additional slow water pool habitat for aquatic organisms. The restored channel reconnected the stream to its floodplain by elevating the stream nearly 4 to 6 feet at the lower end, which will eventually create an additional 17,450 square feet (0.4 acres) of wetlands along the restored stream corridor at a minimum. The project also restored up to 5 acres of riparian habitat by converting adjacent sage brush areas into willow- and cottonwood-dominated valley bottom. Figure 8–Figure 11 depict before and after restoration conditions.

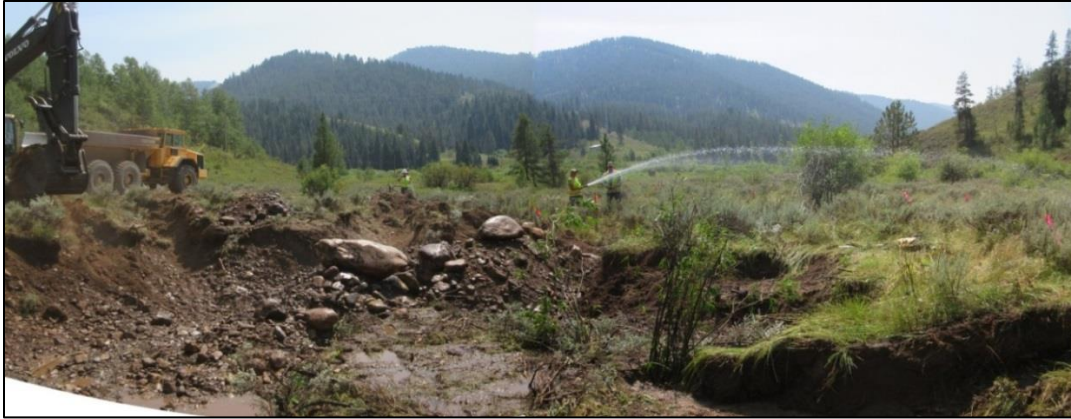
Figure 9. The stream is now reconnected to the floodplain allowing restoration of the riparian habitat (after). Source: USFS.

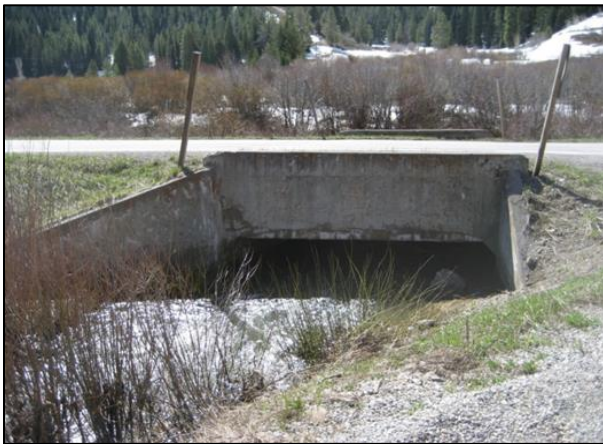
Figure 10. Old Highway 31 Bridge crossing at West Pine Creek (before). Source: USFS.

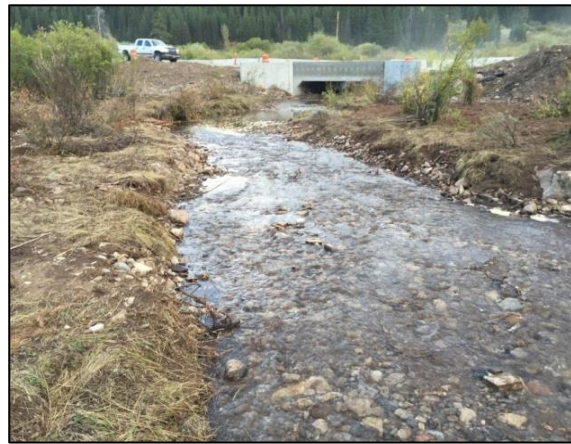
Figure 11. Newly reconstructed bridge. Whole willows were transplanted and whole tree revetment restoration design treatments provided vegetation recovery, stream stability, and instream aquatic habitat (after). Source: USFS.

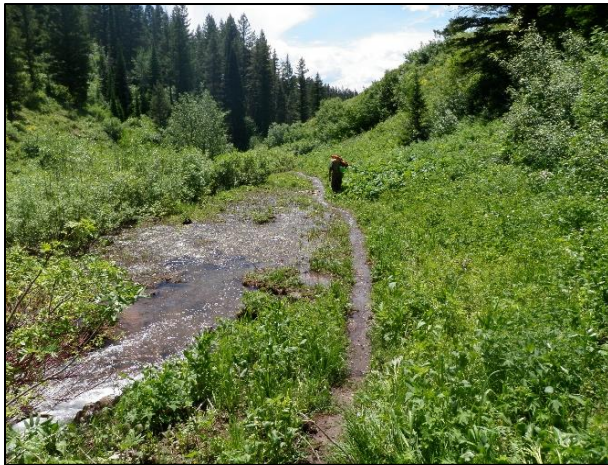
Figure 12. The stream inundated Red Creek Trail during spring runoff (before). Source: USFS.

Red Creek Trail (#241) Reroute (2014)—A 50-foot section of the Red Creek Trail (#241) was rerouted to remedy seasonal events where the stream flowed along the trail. Before and after restoration conditions are shown in Figure 12 and Figure 13.

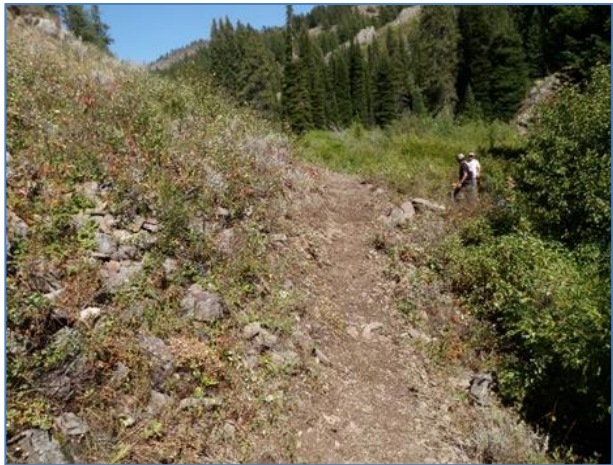
Figure 13. The trail was removed from the aquatic influence zone and the area restored (after). Source: USFS.

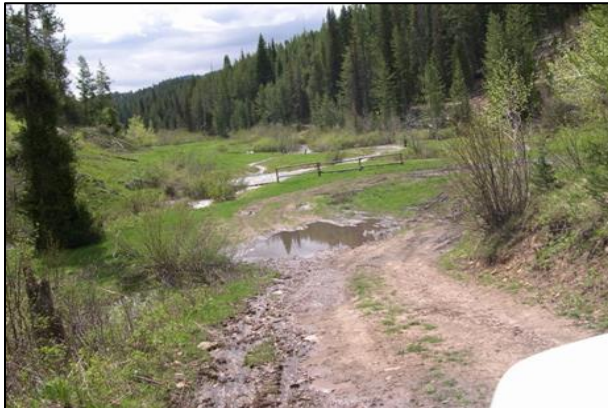
Figure 14. The trail runs through the riparian area (before). Source: USFS.

Tie Canyon Road Repair and Trailhead Relocation (2013)—The project relocated the trailhead out of the riparian area, stabilized streambanks, and enhanced and protected water quality and Yellowstone Cutthroat Trout habitat. The lower section of the Tie Canyon Trail (#200) was relocated further from the stream channel and connected to the new trailhead. The old trail was reclaimed. The project improved road conditions and reduced erosion by placing road material (pit run) and finish layer (3/4 minus) on Forest Service Road 252 and the trailhead. Figure 14 and Figure 15 show before and after restoration conditions.

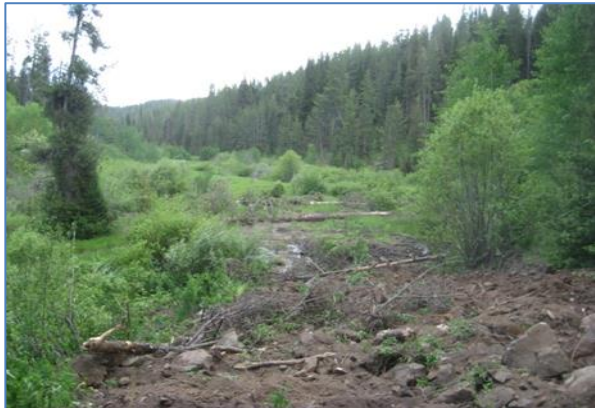
Figure 15. The trail was rerouted and riparian area restored (after). Source: USFS.

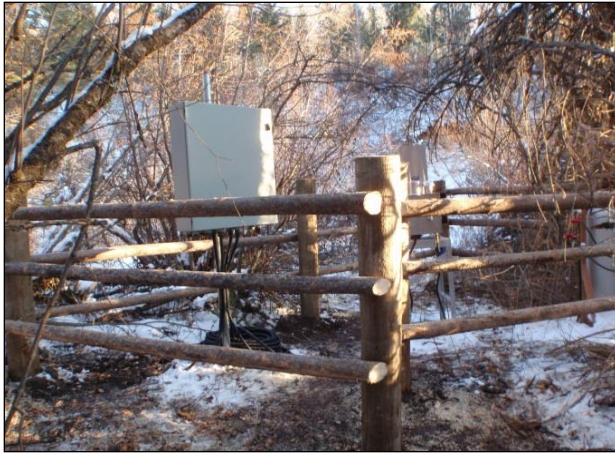
Figure 16. Burns Creek PIT tag antenna receiver. Source: USFS.

Burns and Pine Creeks Passive Integrated Transponder (PIT) Tag Antenna Systems (2011 and 2012)—Two PIT tag antenna systems were installed in the Palisades subbasin to detect directionality of Yellowstone Cutthroat Trout movement (upstream or downstream). The objective of these systems is to better understand Yellowstone Cutthroat Trout movement so appropriate management decisions can be made to ensure their long-term viability in the South Fork Snake River system. Each antenna is approximately 2 feet wide and 20 feet long and is imbedded in the streambed so that the top of the antennas are flush with the streambed allowing gravel and other debris to pass over them. The antennas are attached to a receiver that decodes signals picked up from PIT tags as fish marked with these tags swim over the antennas. These fixed arrays are powered by thermoelectric generators and run on propane. IDFG operates the arrays from April through December. In Burns Creek, two antennas were placed 30 feet apart; in Pine Creek, four antennas were imbedded into the streambed: two across the channel and two more 30 feet downstream. Figure 16 and Figure 17 show the PIT tag antenna system that was installed adjacent to and in Burns Creek.

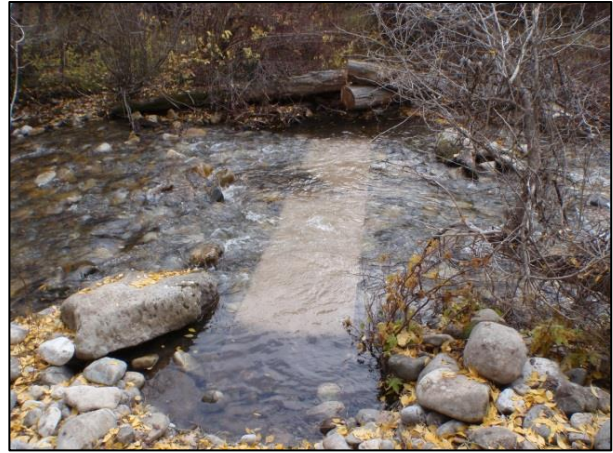
Figure 17. Burns Creek PIT tag antenna. Source: USFS.
